# Test report

Product(Sample)	eArc module
Application Dept.	Production department
Applicant	Xiaowen Liu
Test Company	<u>SUNMAN(ZHENJIANG) CO.,LTD.</u>
Test Date	2021-11-12
Tester

To confirm the effect of eArc module's upper film creases on aging and long-term reliable performance.

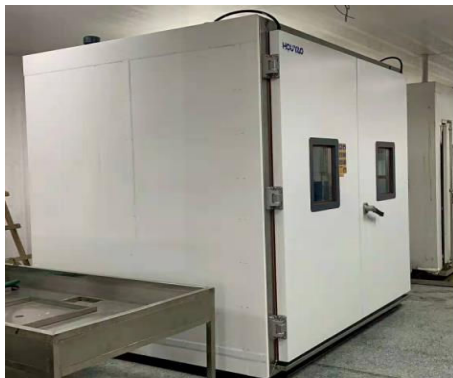
#### 3.1 Damp & heat aging test instrument:

Instrument Name: Damp & Heat Testing Chambers  
Instrument manufacturer: Shanghai Houyao  
Model: HY-BRS-DH-9

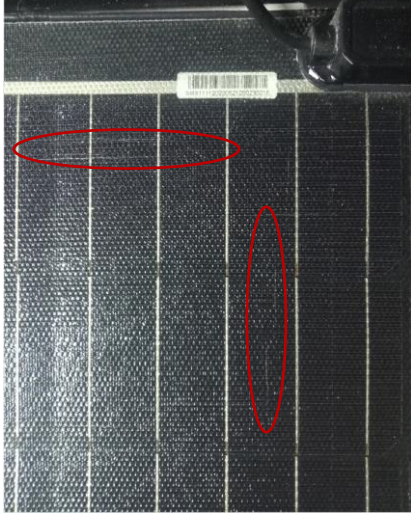
Normal

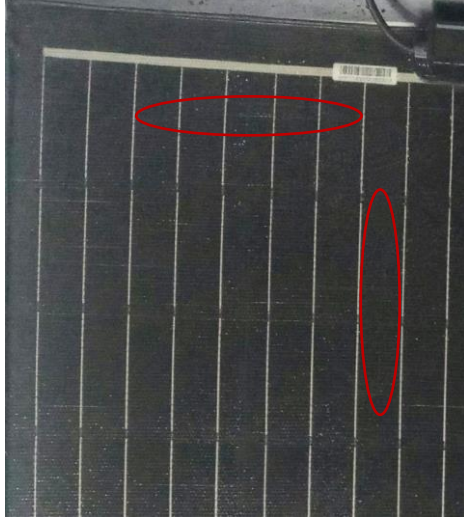
Color: Normal  No obvious abnormalities on the creases area	Pass

After DH1000h, the power degradation is less than 5%, and no obvious abnormalities on the creases area, the power and wet leakage tests both meet the requirements;

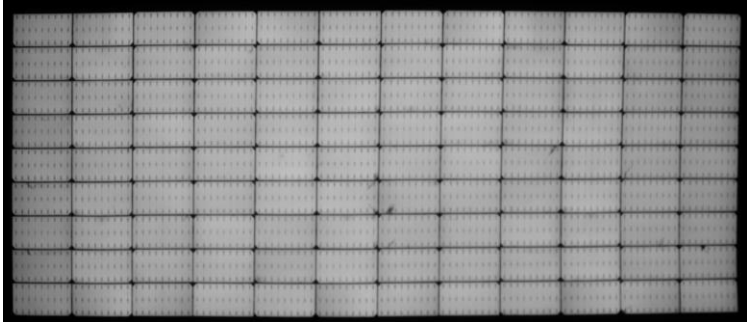
Normal	Pass

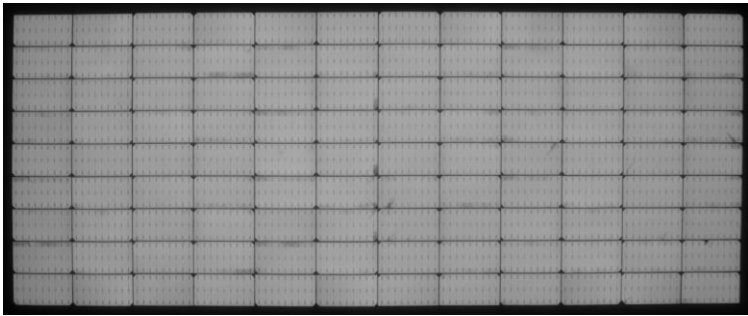
No abnormalities	Pass
--	-------	--	------------------	------

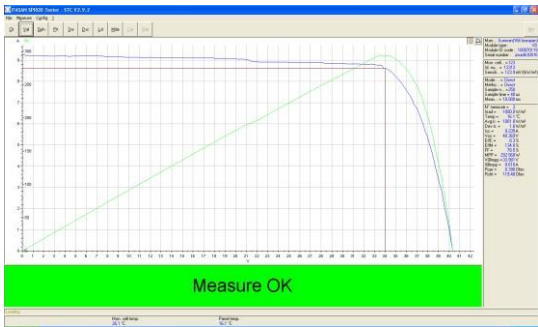
Power: 292.568W	Pass
	1* IEC

No.	Test period	VOC (V)	Vmp (V)	Isc (A)	Imp (A)	Pmp (W)	RS (Ω)	FF (%)	Degradation
1	Before testing	40.369	33.981	9.235	8.610	292.568	0.39	78.5	/
	1* IEC	39.780	33.330	9.336	8.534	284.446	0.41	76.6	2.78%

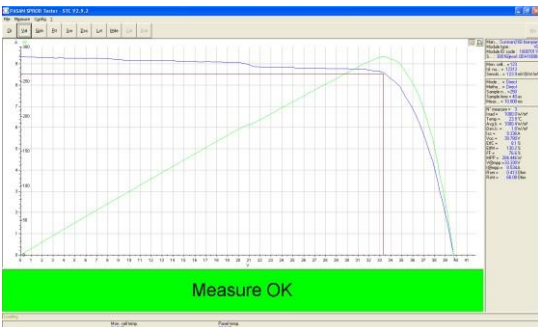
Power: 284.446W Degradation : -2.78%	Pass
